# RETROFIT DESIGN AND CONSTRUCTION FOR MAKING GERBER GIRDERS CONTINUOUS ON THE METROPOLITAN EXPRESSWAY

Tokyo Branch Bridge Engineering Dept. Hidechika WATANABE

Tokyo Branch Bridge Construction Dept. Tatsuyasu BESSHO

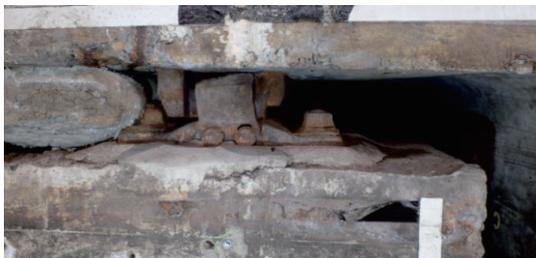
The bridge in this study is a Gerber-hinged bridge with PC box girders on the Metropolitan Expressway Shinjuku Route (Route 4) located in Sendagaya, Tokyo. Being in service for more than 50 years, the bridge shows corrosion of the shoes in the Gerber hinges due to aging (Photo-1) and also damage at notches due to stress concentration. To solve these problems, the Gerber hinges were modified and the girders were made continuous by using external tendons in combination with carbon fibers. This paper summarizes the design and retrofitting of the project.

Photo-1 Damaged shoes found in a Gerber hinge

- Leave the existing shoes in the target Gerber hinges in place, and cast mortar.
- Use primarily the external tendon method which is a tested and proven technique for making the girders continuous. (Preliminary tensioning is made at a force of 20% of the final tensioning force by using a small-size jack.)
- To strengthen the reinforcement which is interrupted at the target Gerber hinges, check the current amount of tensile reinforcement, determine the required amount of additional tensile reinforcement, and apply an equivalent amount of carbon fibers.

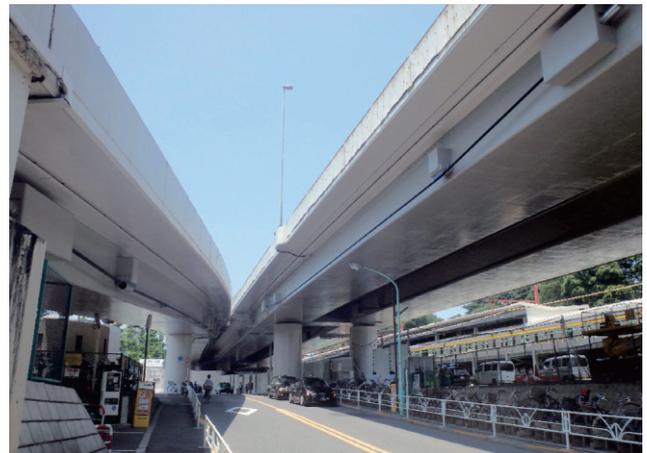
Photo-3 Project completed

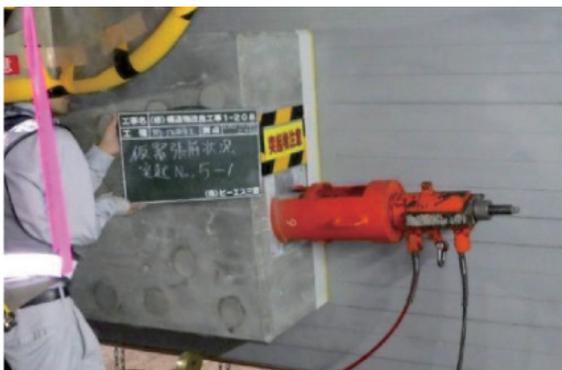
Photo-2 Preliminary tensioning

with the temperature fluctuations could cause gaps in the construction joints in the mortar filling the Gerber hinge gaps. To minimize the problem, the retrofitting work were started from the external tendons in the span with the Gerber hinges. Preliminary tensioning was made at a force of 20% of the final tensioning force by using a small-size jack under restricted operating conditions on a narrow suspended scaffolding (Figure-3, Photo-2). Full tensioning was carried out after installation of the external tendons to the end spans was completed.
